# Carty Road Reconstruction

(NE 10th Avenue – NW Hillhurst Road)

## Clark County

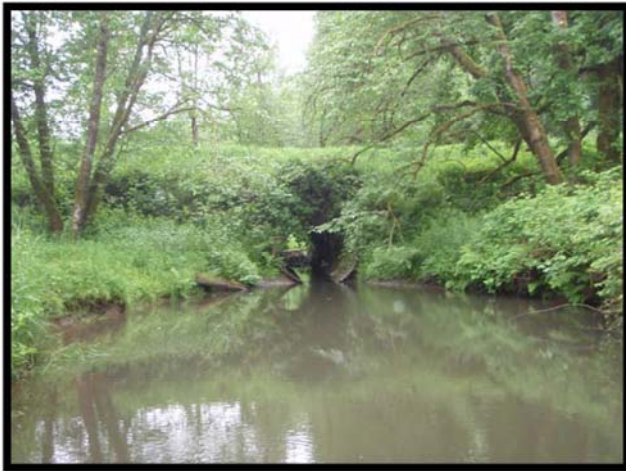
Before – Culvert

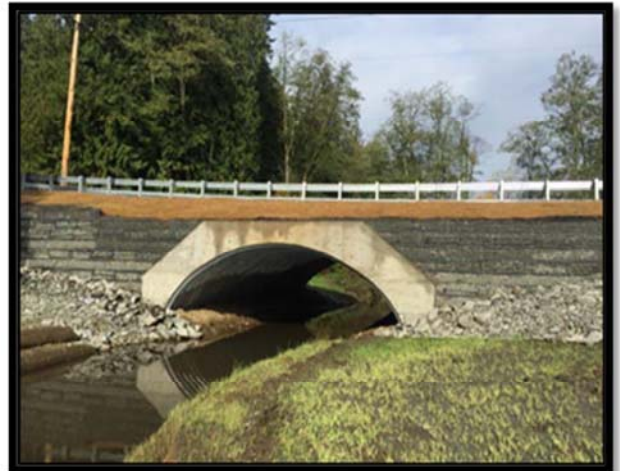
After – Structure

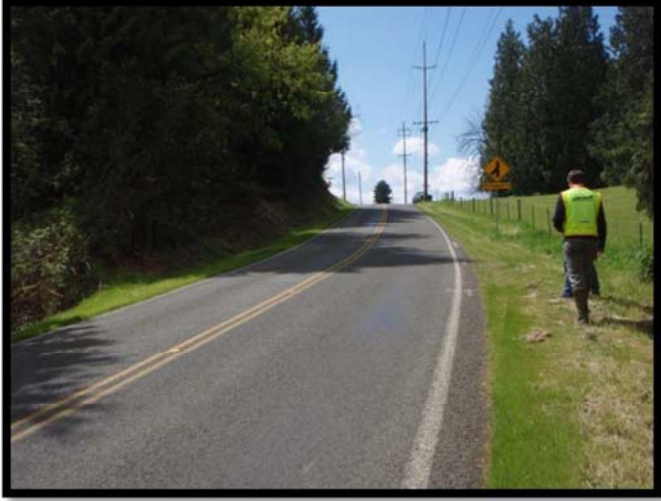
Before – no guardrail

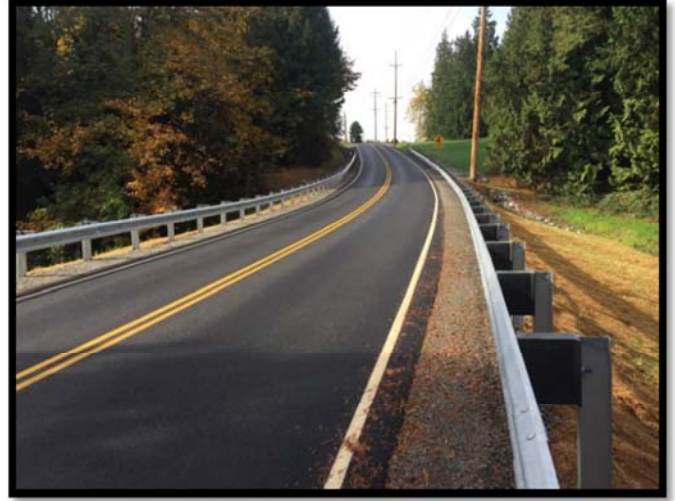
After – guardrail

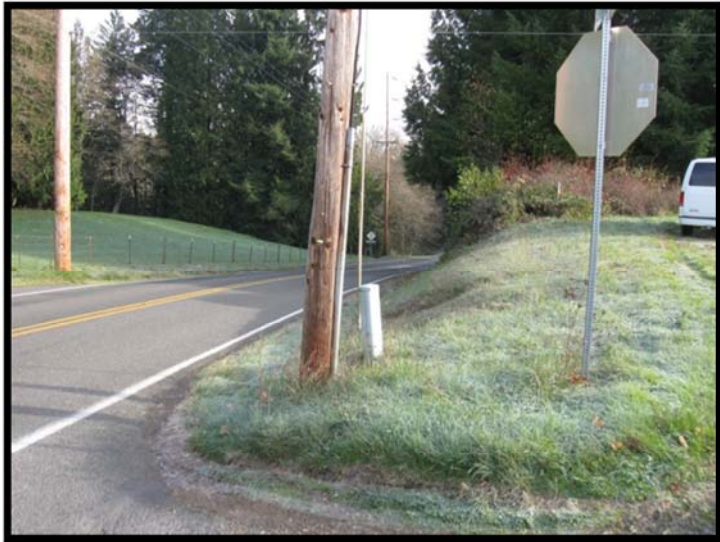
Before – limited sight distance

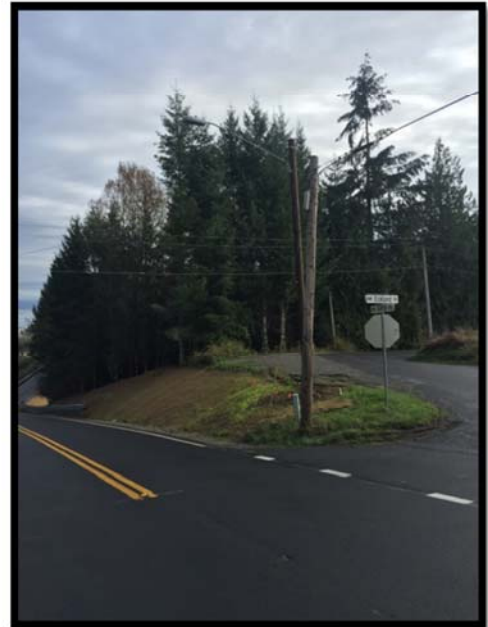
After – improved sight distance

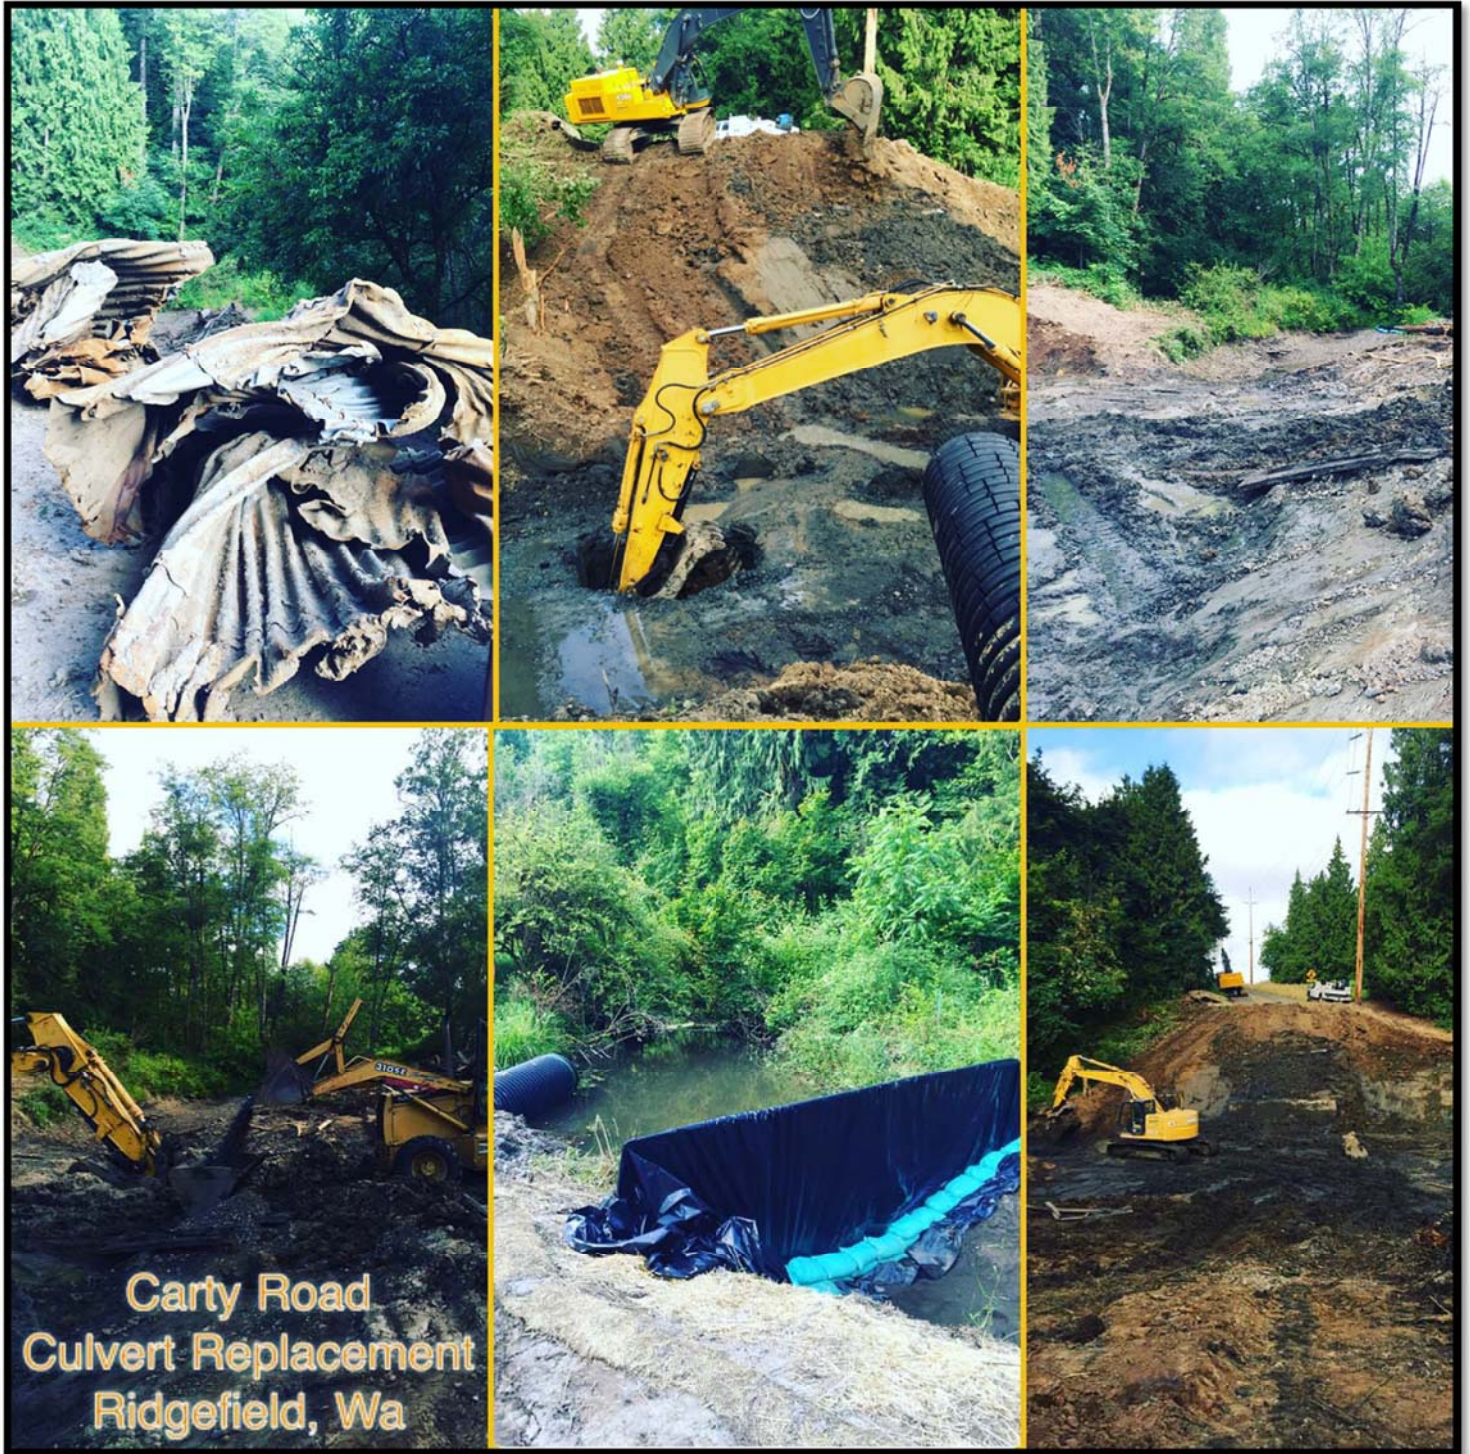
Culvert Replacement – Removal and Under Construction
