INTERSECTION: NE 13th Ave--NE 78th St
 WEATHER:

QC JOB #: 10323702
 DATE: 1/31/2008

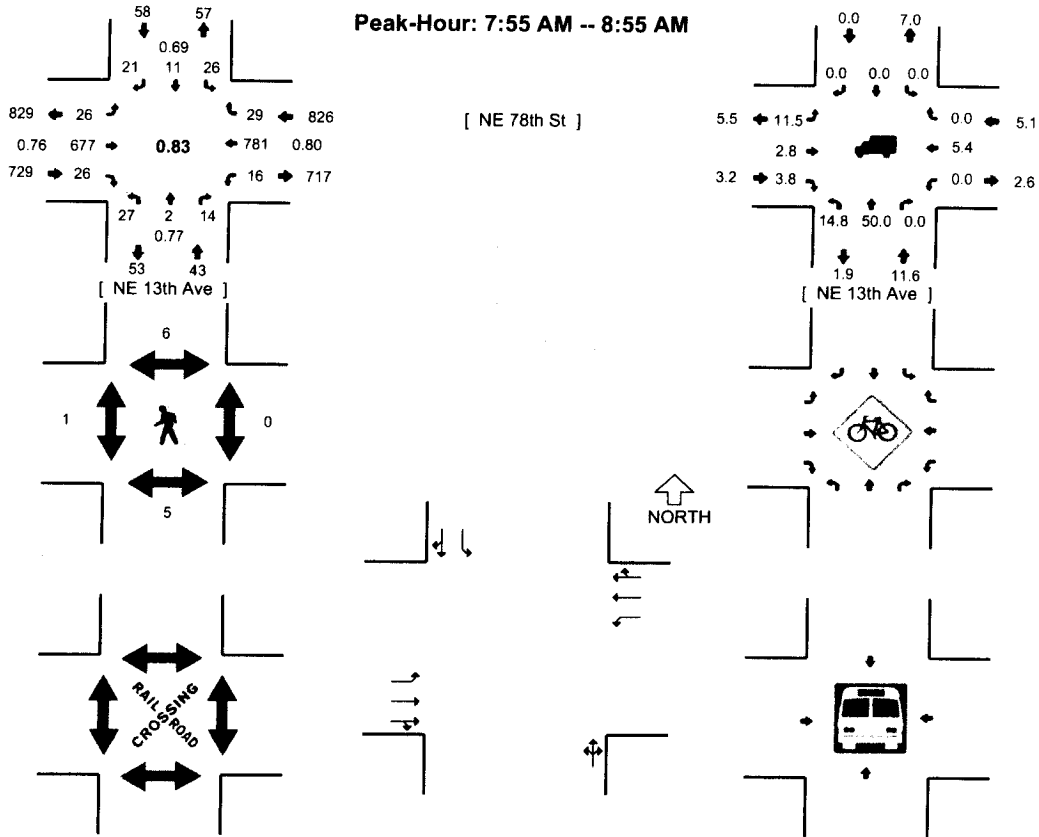
*SEE LEGEND SHEET
